Manhole Inspection Summary

Manhole # S13S__019MH

Insp Date: **2/12/09 11:04 AM**

Location Address: **2920 BENSON AV**

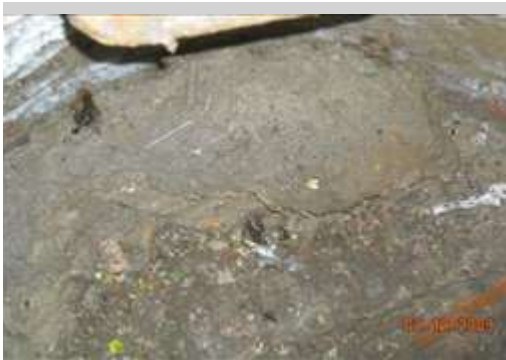
Defect 1

Condition: ☐ Sound ☐ Cracked ☐ Root Intrusion ☐ Deteriorated ☐ Leaks ☒ Debris

DEBRIS ON BENCH

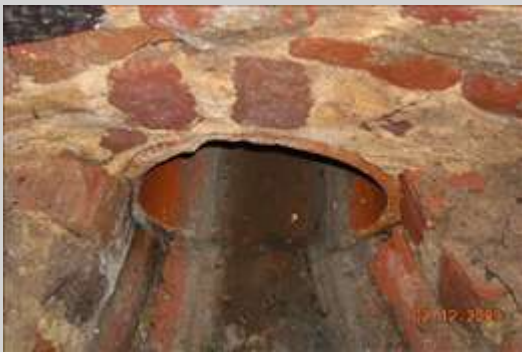
12 O'Clock Outflow

8 in. Circular Gravity Sewer
Pipe Out @ 12 O'Clock

Pipe Height: **8.4** (in.) Rod and Bar (Angled)
Pipe Material: **Clay** ☐ Pipe Lined
Invert Depth: **5.88** (ft.) Flow Characteristics: **Slow**
Deposits: ☒ None ☐ Mud ☐ Sludge ☐ Debris ☐ Grease
Silt Depth: **0** (in.) Deposits Extent:
Infiltration: **None** Pipe Seal Cond: **Sound**

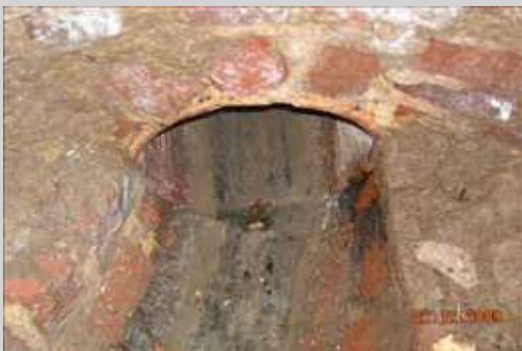
3 O'Clock Inflow

8 in. Circular Gravity Sewer
Pipe In @ 3 O'Clock

Pipe Height: **8.4** (in.) Rod and Bar (Angled)
Pipe Material: **Clay** ☐ Pipe Lined
Invert Depth: **5.85** (ft.) Flow Characteristics: **Slow**
Deposits: ☒ None ☐ Mud ☐ Sludge ☐ Debris ☐ Grease
Silt Depth: **0** (in.) Deposits Extent:
Infiltration: **None** Pipe Seal Cond: **Sound**

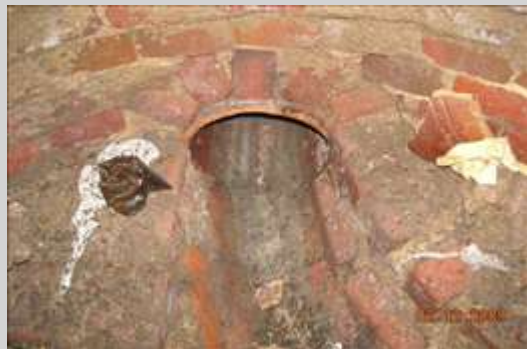
9 O'Clock Inflow

8 in. Circular Gravity Sewer
Pipe In @ 9 O'Clock

Infiltration: **None**

Pipe Seal Cond: **Sound**
